Protection of transmission line towers during landslides - A case study

North East Transmission Company (NETC) is entrusted with construction and maintenance of its 662.8 Km, 400 kV Double Circuit transmission line in the difficult hilly & dense forest terrain in the states of Tripura, Meghalaya and Assam in the North Eastern Region (NER) of India. The terrain consists of various types of soils viz. laterite, alluvial, loamy, red soil etc. and is prone to sinking and landslides due to steep gradient and soil characteristics accompanied with heavy rains in NER. The transmission line route traverses through areas of high rainfall, wind zones of V & VI and high Isokeraunic level.

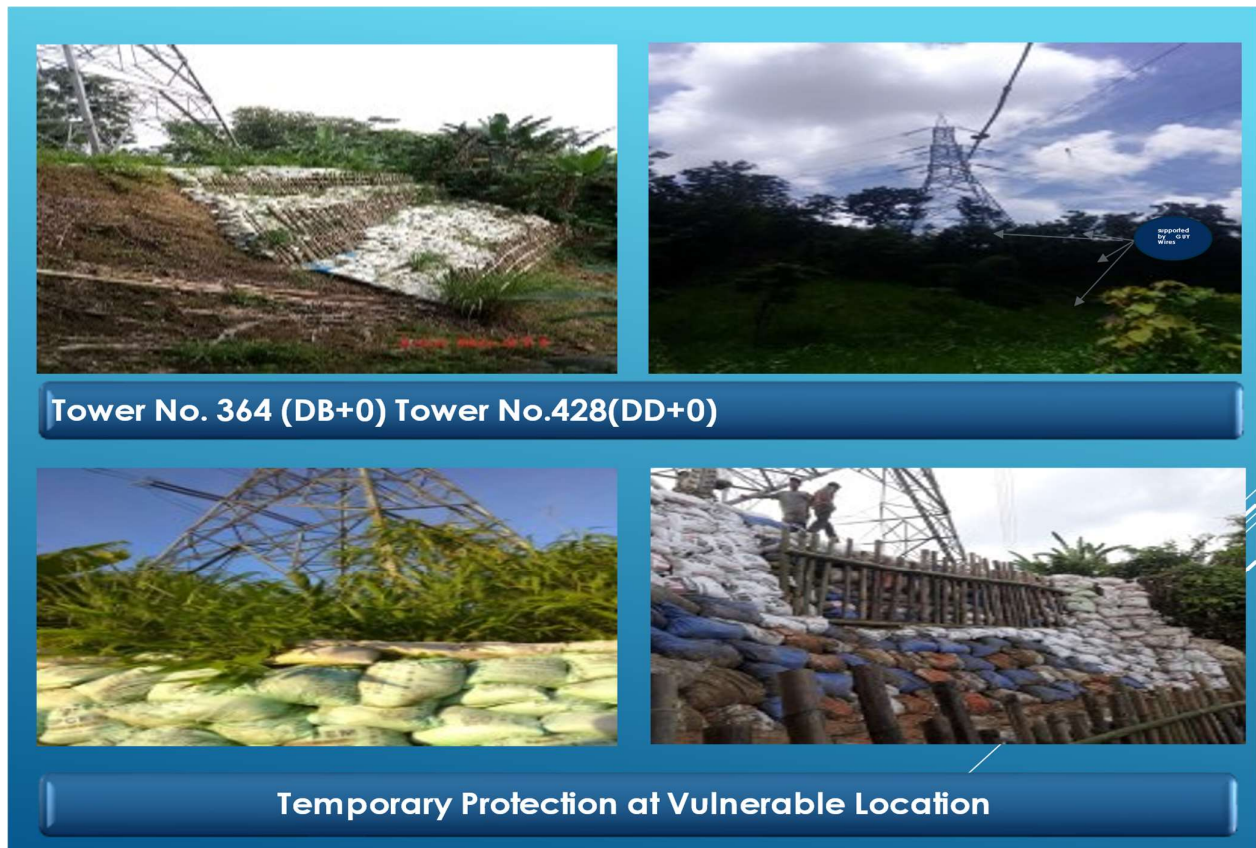
As an immediate temporary measure to protect these vulnerable towers, bamboo palisade in multi steps was provided along with empty cement bags filled with earth providing minimum protection. Sufficient plantation was also done in the eroded sides of the locations to retain the soil. Temporary protection work includes the shifting of material at tower locations, supply of cement bags filled with soils, erection of Bamboo Basket/ Palisading work.

Figures for Temporary Protection Locations with Guying arrangement.

Bamboo anchors the soil with its spreading root system thus preventing landslides. Apart from this, bamboo is used as barrier against soil erosion and other environmental services such as protection of water sources through reforestation of watersheds. Bamboo is a fast-growing plant and its wide network of roots and rhizomes is highly effective in keeping a check on soil erosion by holding/binding the soil firmly, thereby preventing soil loss from ravines.

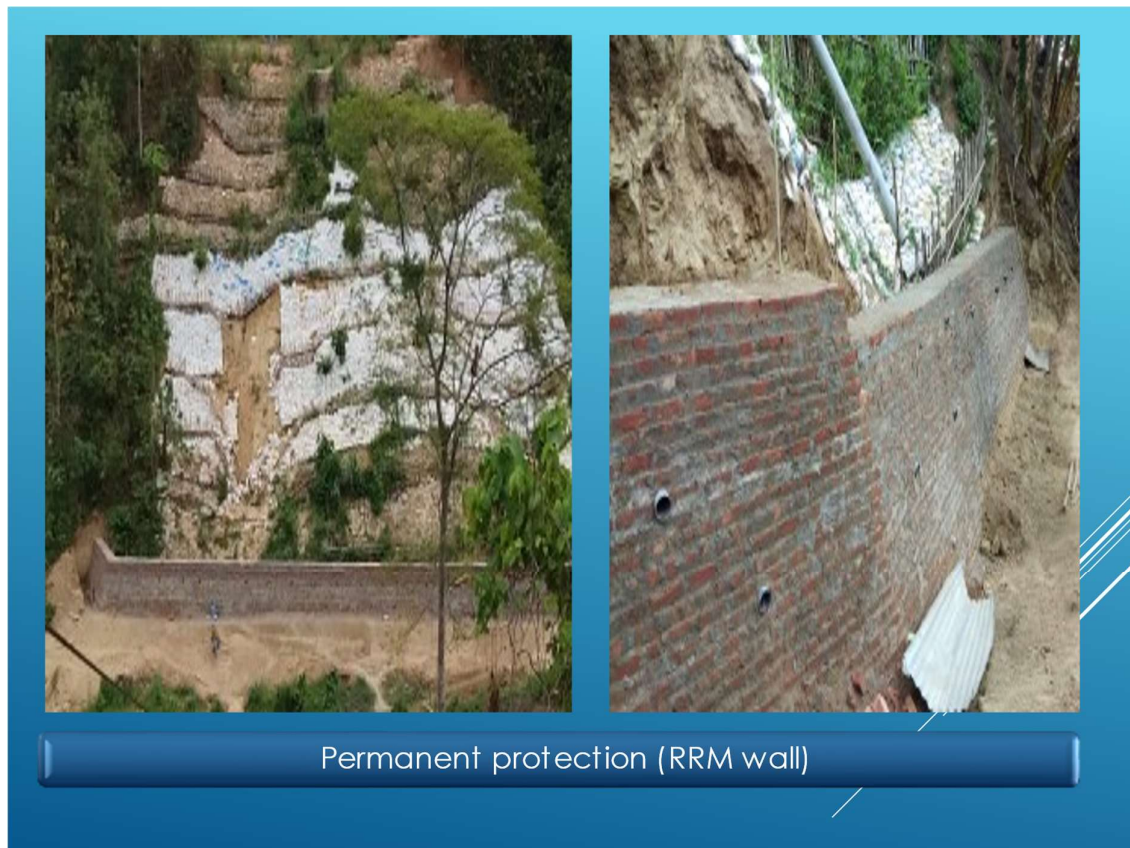
Retaining wall /Revetment walls helps to support hill Slopes and are designed to stop the active pressure of soil. The construction of Revetment/ RRM (Random Rubble Masonry) wall involves the earth work excavation by manual and mechanical means, head loading of requisite materials to tower locations, construction of temporary access roads to the tower locations, providing and laying in position Cement Concrete (1:2:4, 1 Cement, 2 Coarse sand, 4 graded stone aggregate 20 mm nominal size) and back-filling of available excavated earth. The work includes all necessary stone revetment, concreting, earth filling above ground level, providing suitable revetment or galvanized wire netting and meshing packed with boulders. Weep holes are provided to slop down to drain the water.

Figures for Revetment wall Locations with Guying arrangement

However, as the measures taken were temporary in nature to provide immediate protection, permanent protections measures were subsequently taken up. Random Rubble Masonry (RRM) walls were constructed in 10 (Ten) badly affected tower locations before the onset of next monsoon to provide permanent protection.

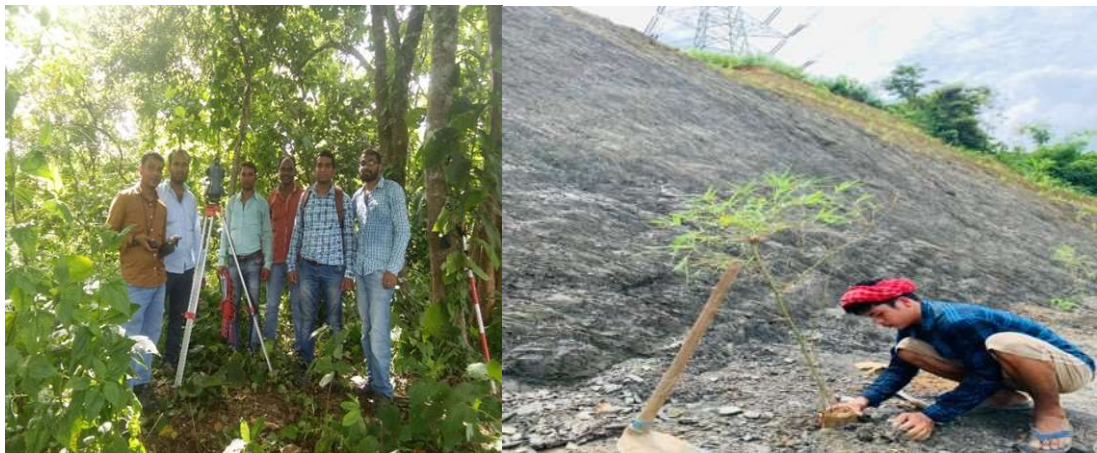
Photographs of Committee visit & Workman planting a tree near tower.

Further, to ensure stability of the slopes, more plantation work have been carried out in these locations which help in reducing soil erosion. For stability of soil, natural vegetation is provided by NETCL.
