Maiden Agartala site visit of Shri Jai Shankar, Managing Director, NETC

On 21.05.2025 MD, NETC along with Agartala team visited vulnerable tower locations on Palatana – Silchar section, severely affected due to Natural disaster in Aug 2024. The brief report are as follows.

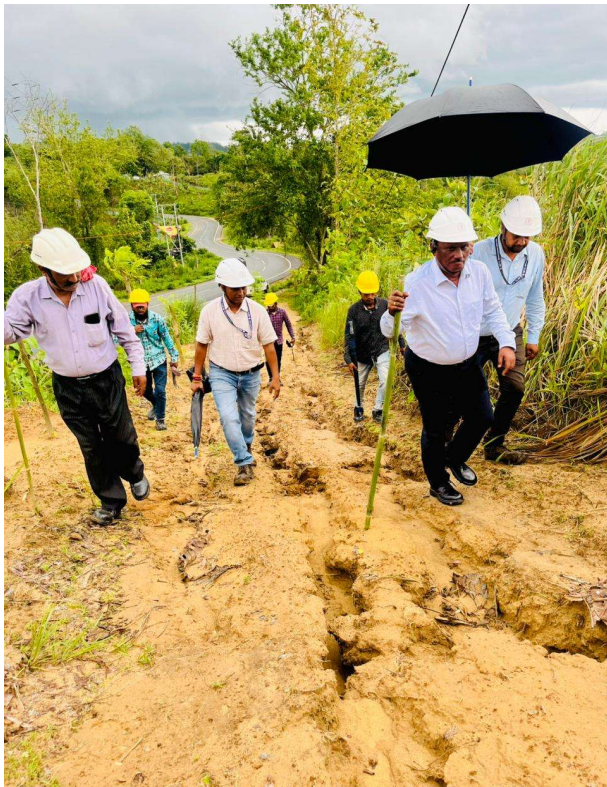
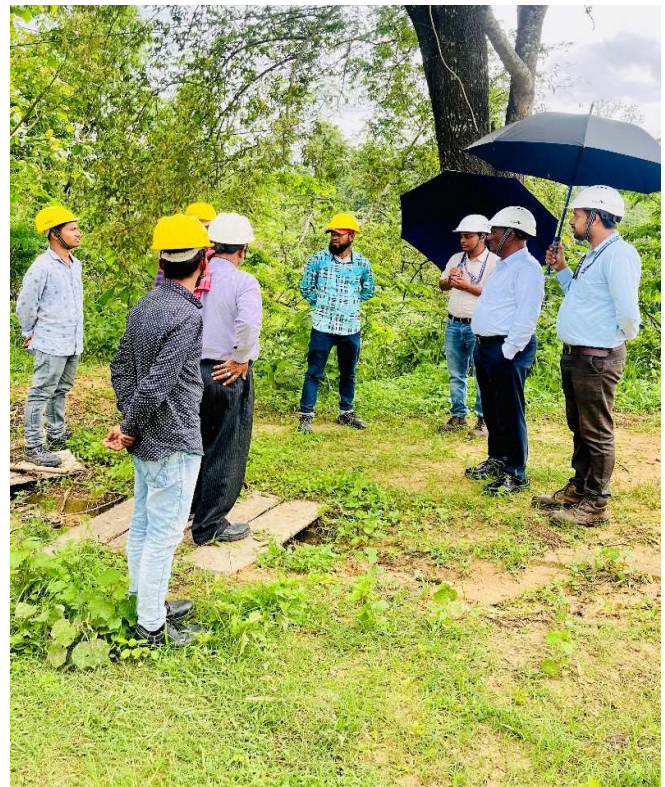
Tower Loc. No. 200: Soil erosion observed near Leg "C", now only 8m from a steep 22m slope and proximity to the NH-08. Protection measures using RRM wall with geonet, as recommended by NERPC sub-group, discussed with Agartala TLM team.

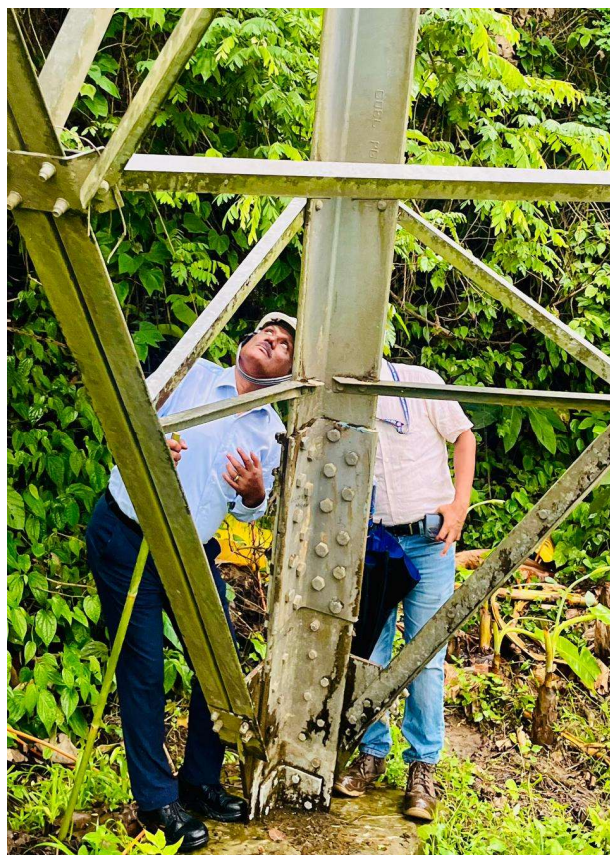
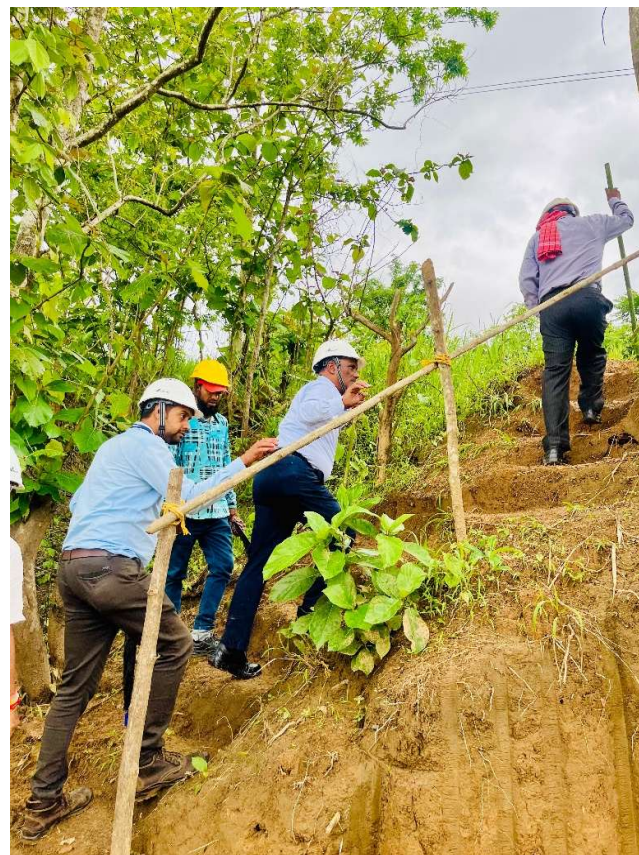
Tower Loc. No. 217: Located 25m horizontally and 20m vertically below NH-08. Sinking and cracking of NH-08 has compromised tower foundation, causing bracing deformation, bending of 34 nos lattice pieces and mild buckling in Legs C and D. During the visit, measures on short term and long- term plan to ensure the safety of asset was deliberated, as recommended by NERPC.
